# Fatal Thunderstorm Encounter, Lehman, Texas

BY DICK ROCHFORD, ATP, CFII - MASTER INSTRUCTOR

**NTSB Identification:** GEN14FA300  
**14 CFR Part 91:** General Aviation  
**Accident occurred** Wednesday, June 18, 2014,  
**in** Lehman, Texas  
**Aircraft:** PIPER PA-46-310P, registration:  
**N2428Q**  
**Injuries:** Three fatal.

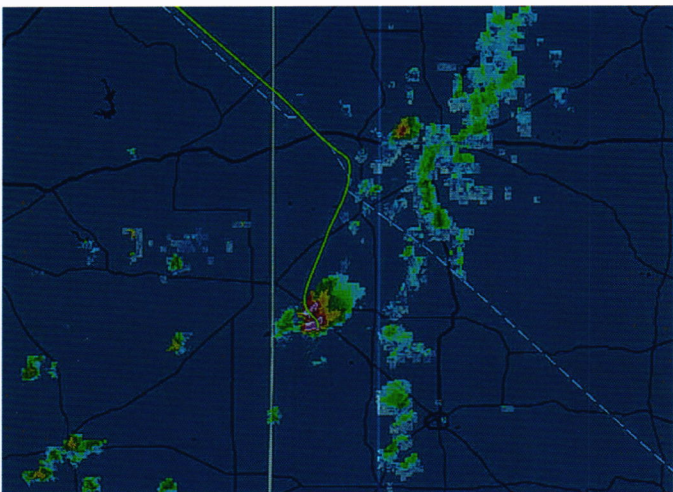
This composite image suggests that a weather deviation was flown, which took the aircraft directly through the worst part of the weather. This is particularly troubling because this particular PA-46 aircraft most likely was not equipped with an operational on-board weather radar system.

This composite image suggests that a weather deviation was flown which took the aircraft directly through the worst part of the weather. This is particularly troubling because this particular PA46 aircraft most likely was not equipped with an operational on-board weather radar system.
