## Controlled Flight Into Terrain During Takeoff - Clayton, Ga.

Clayton, Ga. - 26 Jul 2014  
 NTSB Identification: ERA14FA359  
 14 CFR Part 91: General Aviation  
 Accident occurred Saturday, July 26, 2014, in Clayton, Ga.  
 Aircraft: PIPER PA-46-310P, registration: N248SP  
 Injuries: One Fatal.

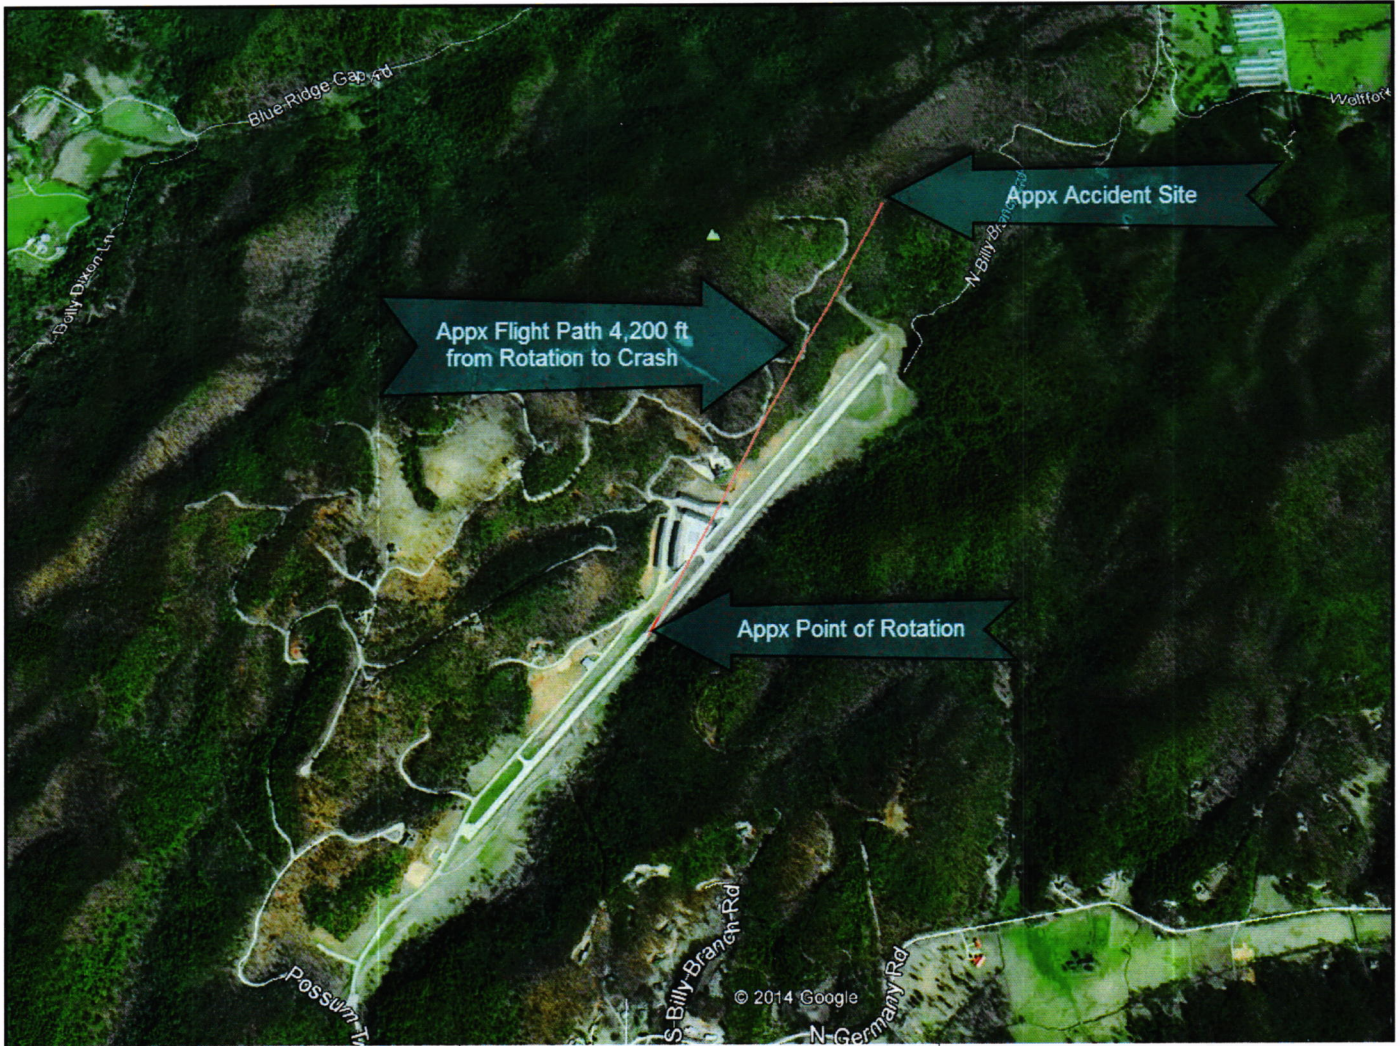
The airplane crashed into elevated terrain, in a heavily wooded area, about 1,500 feet north of the departure end of Runway 5. The elevation at the crash site was about 300 feet higher than the elevation at the departure end of Runway 5. A majority of the wreckage was consumed in a post-crash fire. All major structural components of the airplane were accounted for within the wreckage debris path. Numerous tree limbs were scattered along the debris path with smooth, angular cuts through the limbs.

(ABOVE) The aircraft crashed left of the extended centerline approximately three-quarters of a nautical mile from the point of rotation in rising terrain 300 feet higher than the field elevation.
