# **Safety Review**

## **Piper Malibu/Mirage**

**Model PA-46**

**AOPA Air Safety Foundation**

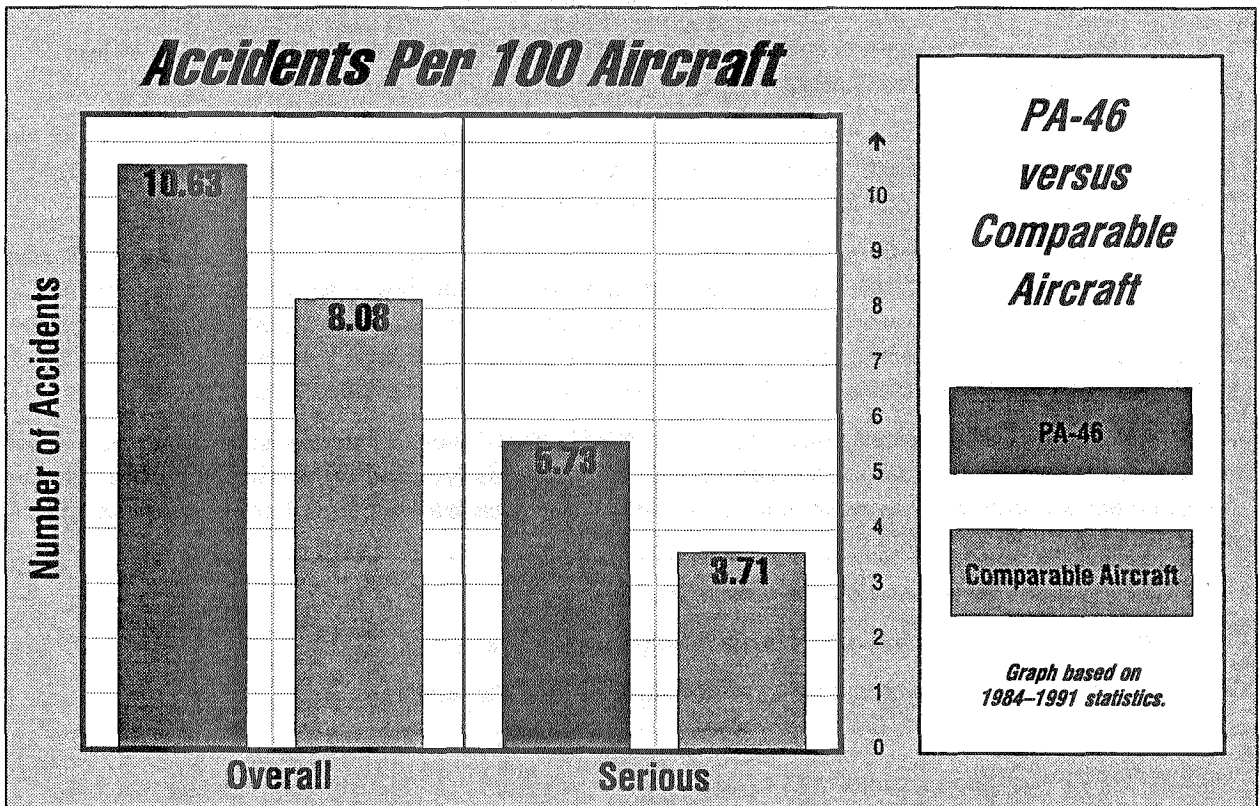
The two measures are shown in Figures 2 and 3. Figure 2 compares the rate of PA-46 accidents per 100 PA-46s built to the rate of accidents per 100 airplanes manufactured in the comparison group (see list page vi). The first two bars depict the overall accident rate for both serious and minor accidents. Bars three and four show serious accidents only. In Figure 3, each 100,000 hours flown in the PA-46 and in the comparison group respectively are categorized by 1) overall accidents, and 2) serious accidents.

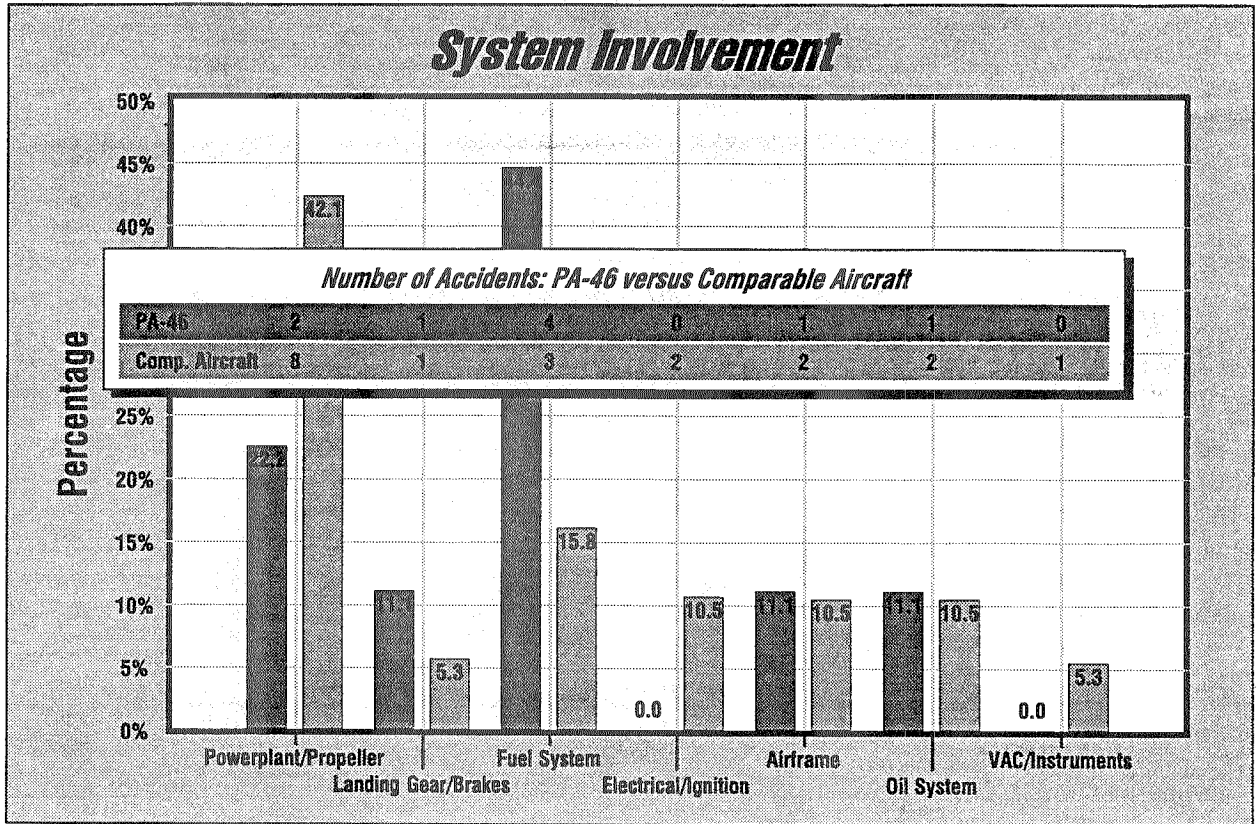
Figure 11

Of the 35 total accidents studied, nine accidents or 25% were attributed to mechanical/maintenance causes. The most predominant accident occurrence involved the fuel system, with four of nine total accidents. The most common problem with the fuel system was leaks in the fuel lines. One powerplant failure accident involved a crankshaft failure and another a cylinder separation in flight. See PA-46 Maintenance Summary (page 2-63) and individual mechanical/maintenance accident reports (pages 2-30 through 2-38) for additional information. Note that with the small number of accidents this will have a disproportionate effect on the percentage.

Significantly, the primary cause of two PA-46 night accidents was mechanical/maintenance related rather than pilot error (an accident is coded as a night accident if the **Lighting** field on the NTSB final report is recorded as Night). For additional information regarding mechanical/system related accidents, see figure 11, page 1-11.

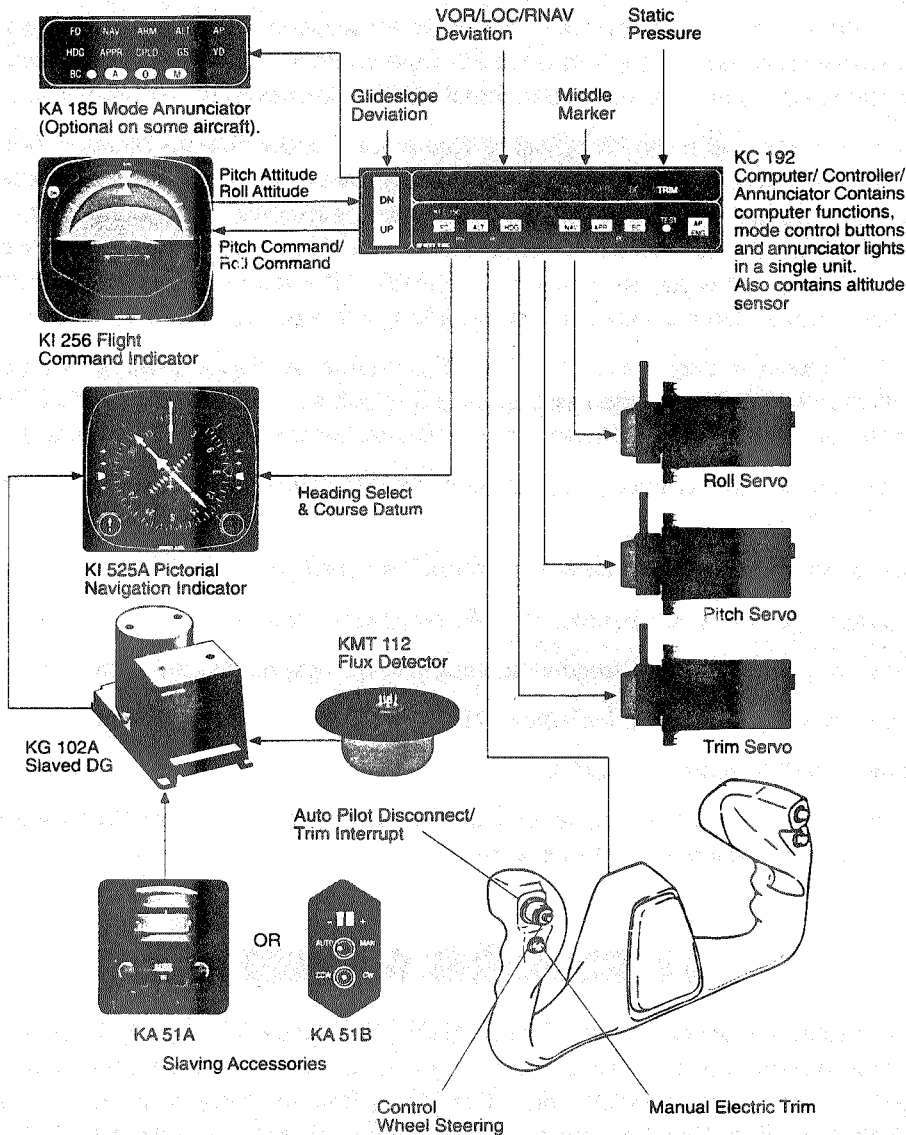
# Typical KFC 150 Flight Control System

## Two Axis (Pitch & Roll) System
